PROFESSIONAL ENGINEERING &  
GENERAL CONTRACTING SERVICES

November 20, 2017

### **Russell Township Fire Station – Cursory Review**

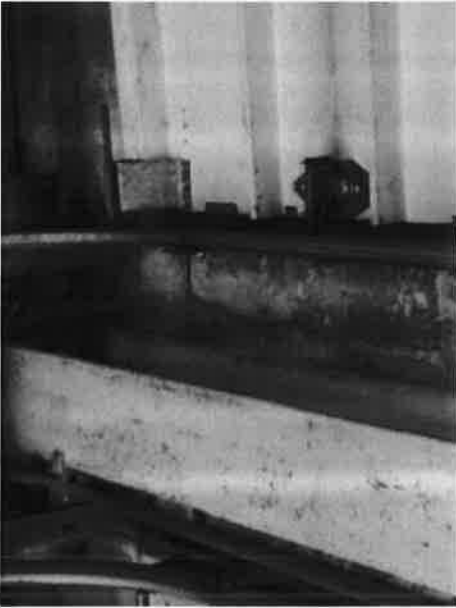
1- PIER CRACK AT LINTEL

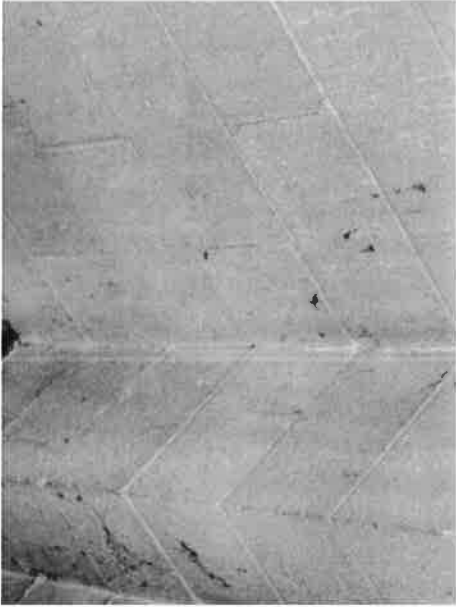
2- STAIR STEP CRACK AT CORNER

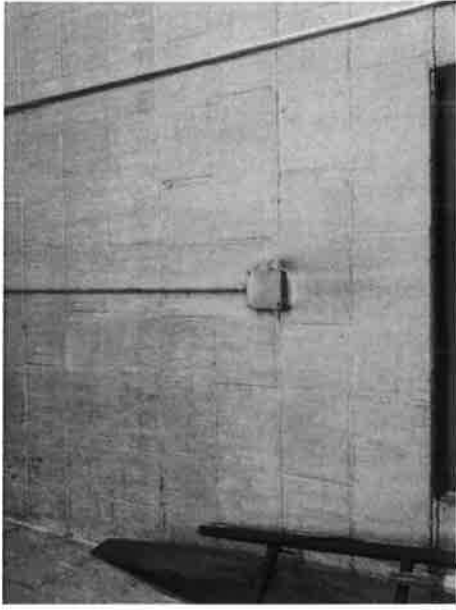
3- STAIR STEP CRACK AT MANDOOK AND HORIZ. CRACKS AT LINTEL

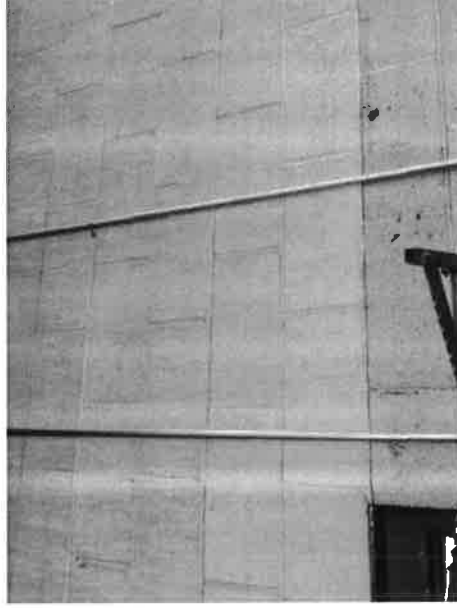
4- STAIR STEP CRACK

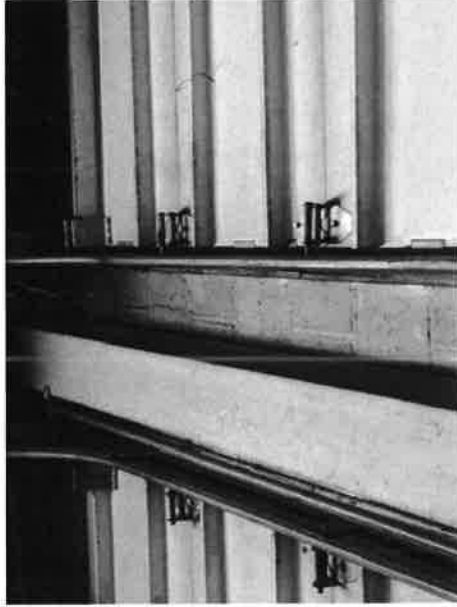
5- CRACK AT LINTEL

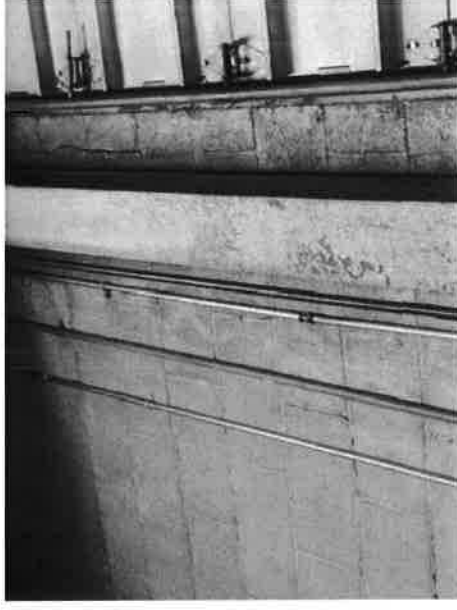
6- CRACK AT LINTEL

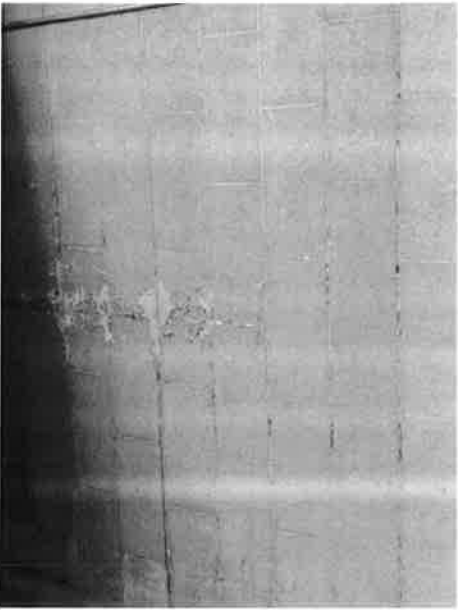
7- MOISTURE DAMAGE AND HORIZONTAL CRACKS

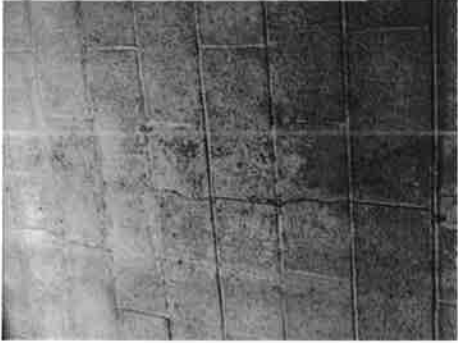
The service garage had vertical cracking in the full height walls spaced at approximately four feet on center (regularly) along with stair step cracking at openings and corners (see attached pictures for reference). Also noted was horizontal cracking along the tall walls located at approximately eight feet above finish floor. The horizontal cracking is typically indicative of no vertical reinforcing and solid grouting in the existing CMU.

8- VERTICAL CRACKS @ 4' O.C. TYP.

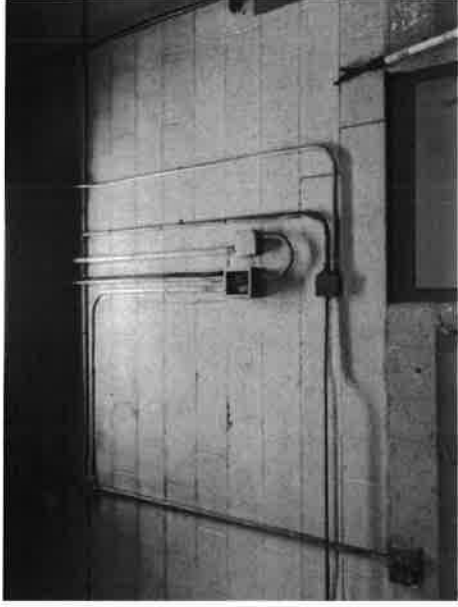
9- STAIR STEP CRACK AT MANDOOR

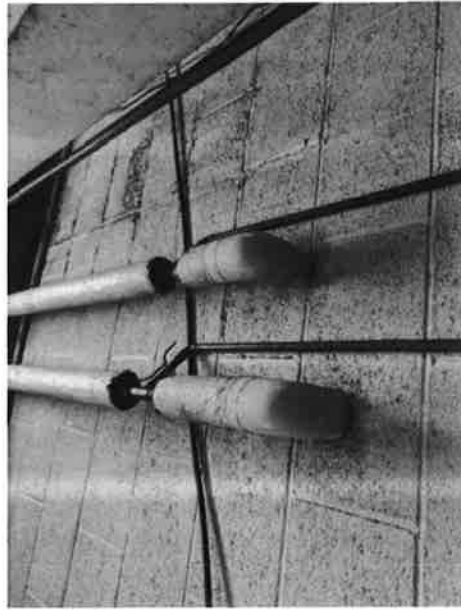
10- STAIR STEP CRACK

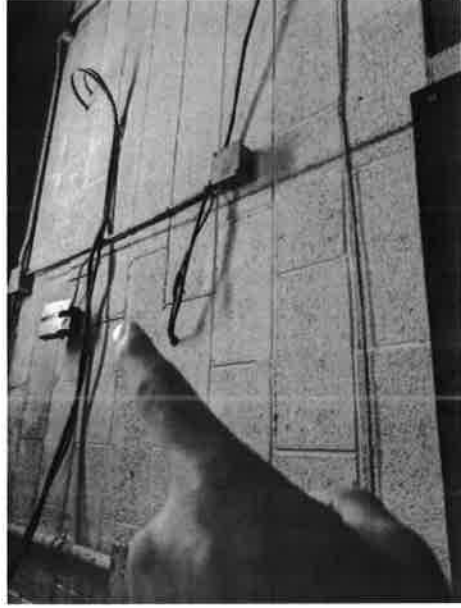
11- VERTICAL CRACKS OVER DOORS

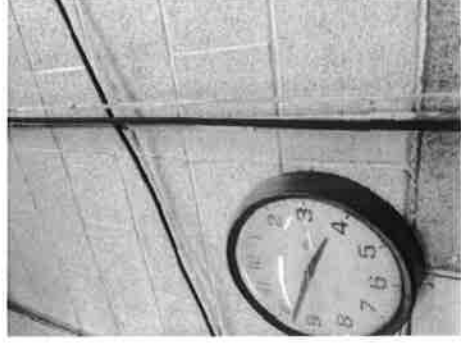
12- VERTICAL CRACKS

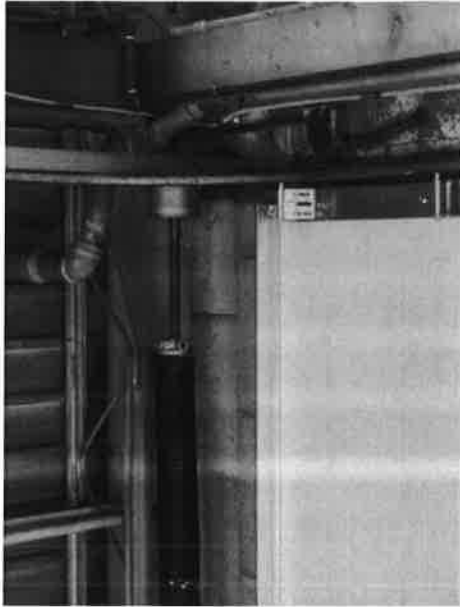
13- CRACKS AT OVERHEAD DOOR

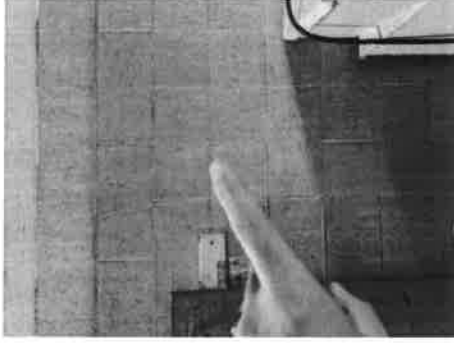
15- VERTICAL CRACK

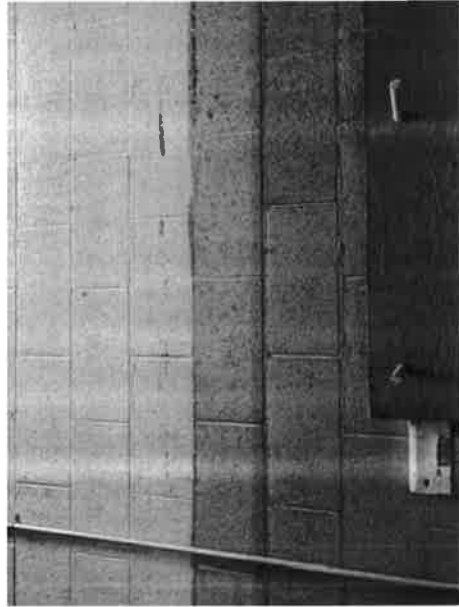
16- STAIR STEP CRACK AND VERTICAL CRACK

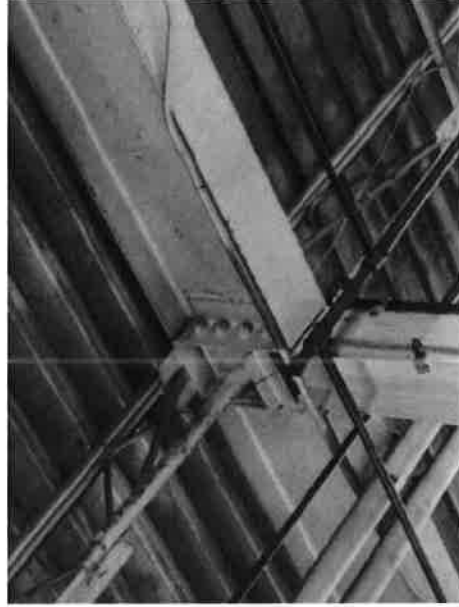
17- TYPICAL INTERIOR STEEL CONNECTIONS

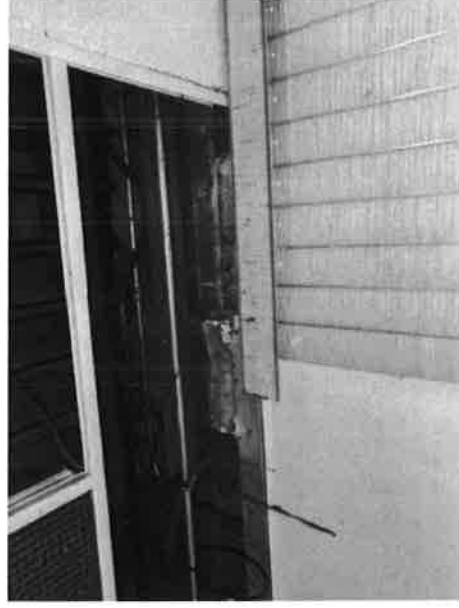
18- 4" CMU AT NORTH WALL

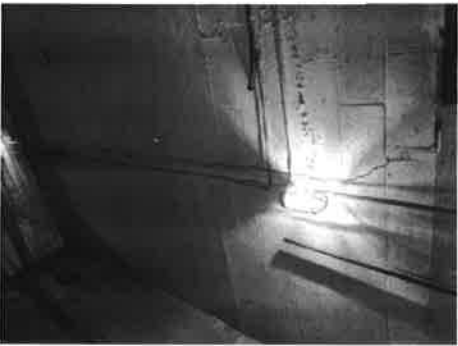
19- LARGE VERTICAL CRACK EXTENDING TO LINTEL

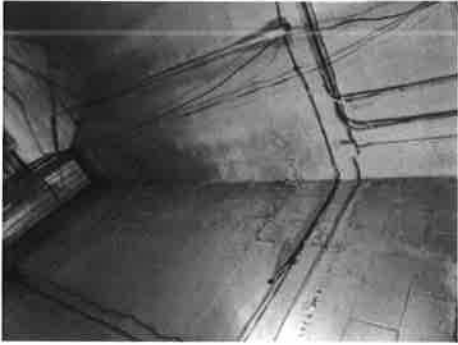
20- WATER DAMAGE AND MASONRY CRACKS

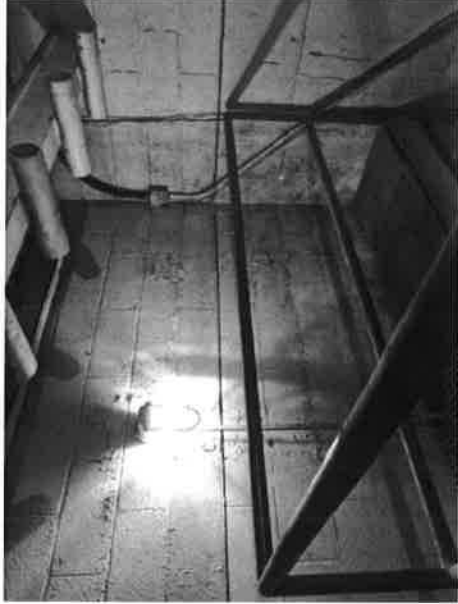
21- SEVERE HORIZONTAL CRACK AROUND ENTIRE PERIMETER

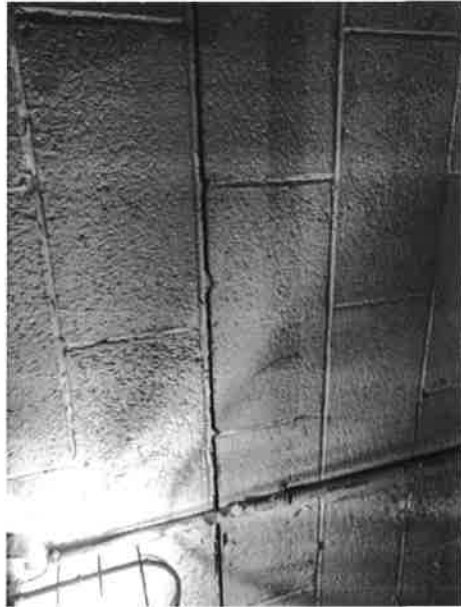
22- CLOSE UP OF CRACK

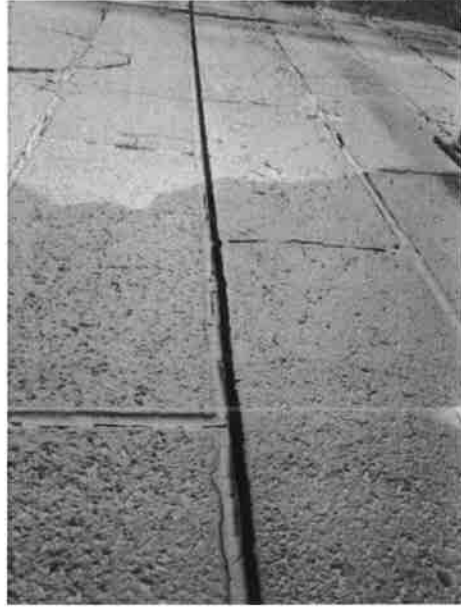
23- ANOTHER PERSPECTIVE OR HORIZ. CRACK

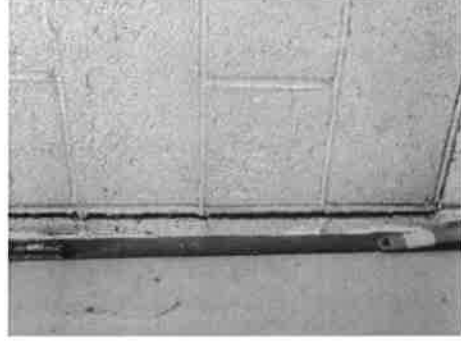
24- VERTICAL CRACK BETWEEN GARAGE AND TOWER

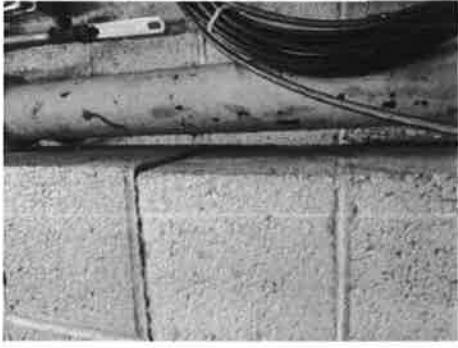
25- HORIZONTAL CRACK AT NORTHEAST CORNER OF GARAGE

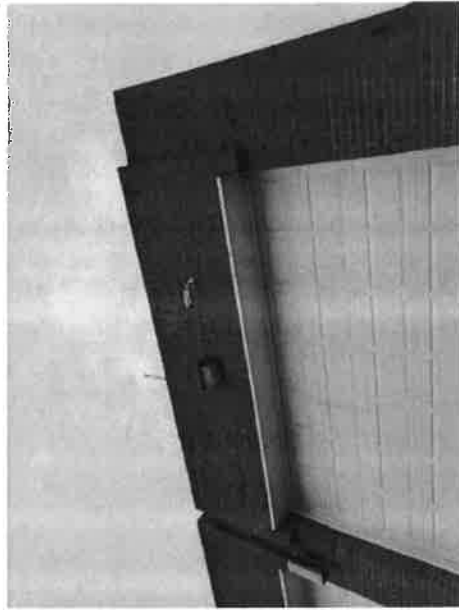
26- LARGE CRACKS AT OVERHEAD DOOR, SIGNS OF EXTENSIVE WATER DAMAGE

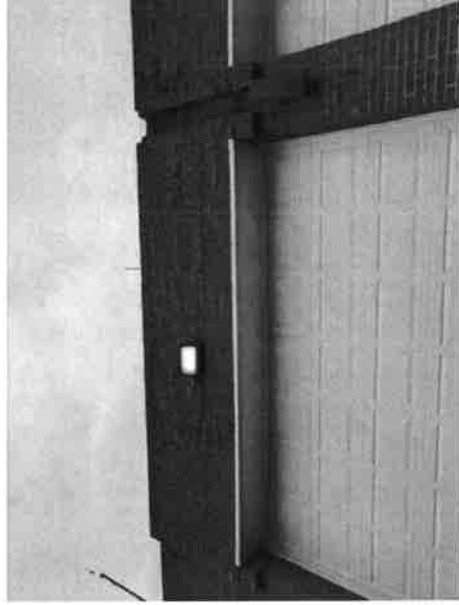
27- LARGE HORIZONTAL CRACKING AT OVERHEAD DOOR, SIGNS OF EXTENSIVE WATER DAMAGE
